Subject: August 7, 2014 Compliance Evaluation Inspection

CWA COMPLIANCE EVALUATION INSPECTION REPORT
U.S. ENVIRONMENTAL PROTECTION AGENCY, REGION 5

Compliance Evaluation Inspection

August 7, 2014

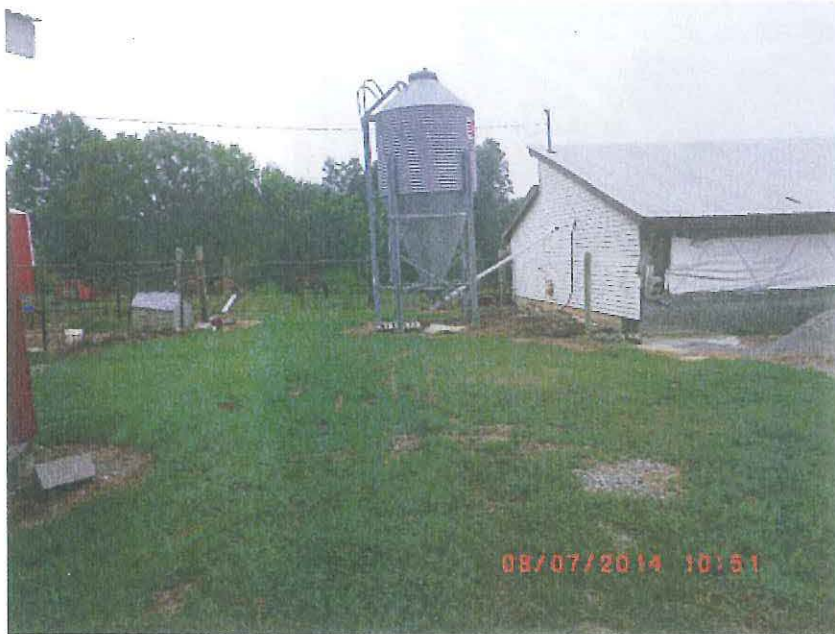
1: IMGP1221

Description: East end of Barn 7.

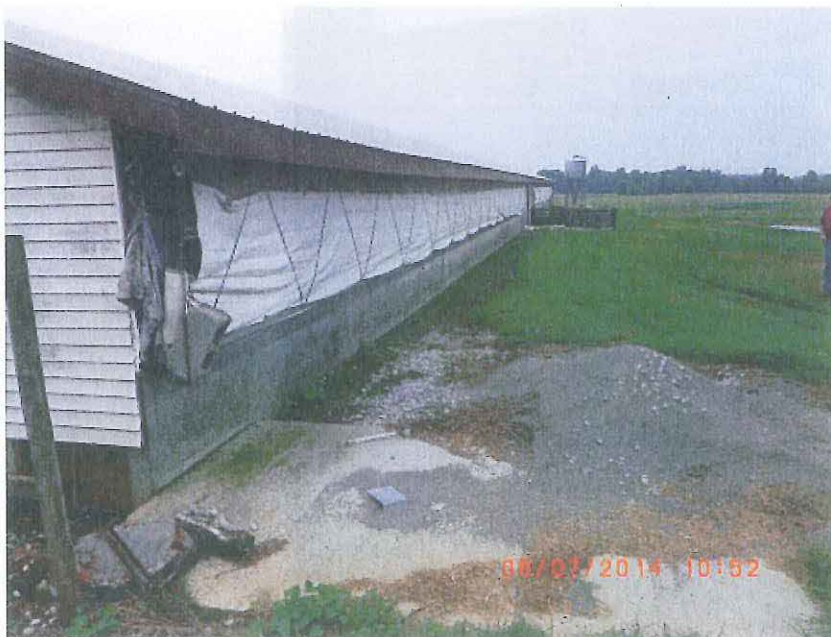
2: IMGP1222

Description: Barns 7 & 8 are located under one roof. Barn 7 is the east half and Barn 8 is the west half of the building. These barns utilize a shallow pit/pull plug system.

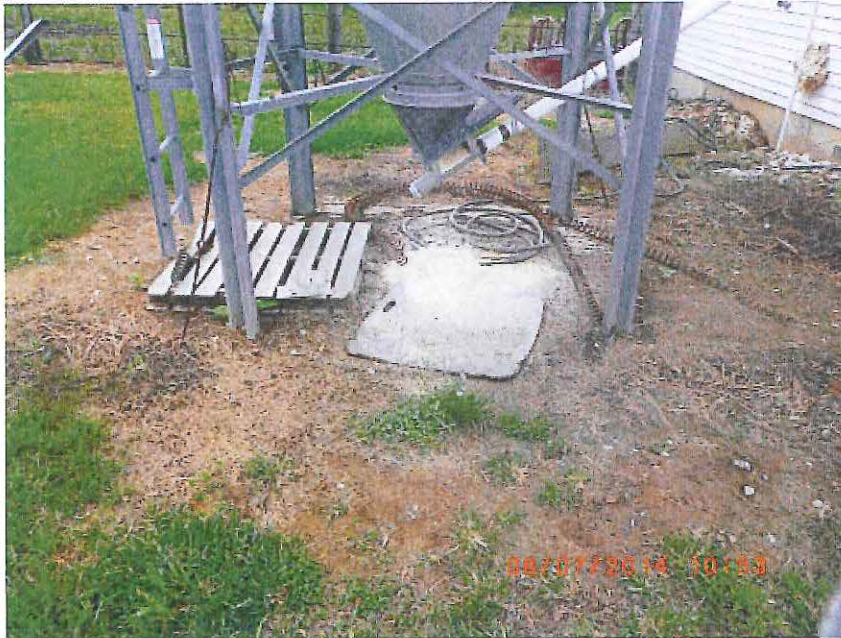
3: IMGP1223

At the east end of Barn 7, EPA observed some spilled feed below the bulk bin for this barn and eroded ground at the end of the barn whereby storm water could enter the pit. EPA discussed both of these issues with the owner. The addition of storm water in the pit would be additional water to the manure ponds and lessen the capacity in them.

Description: Some feed spilled below the bulk bin on the east side of Barn 7.

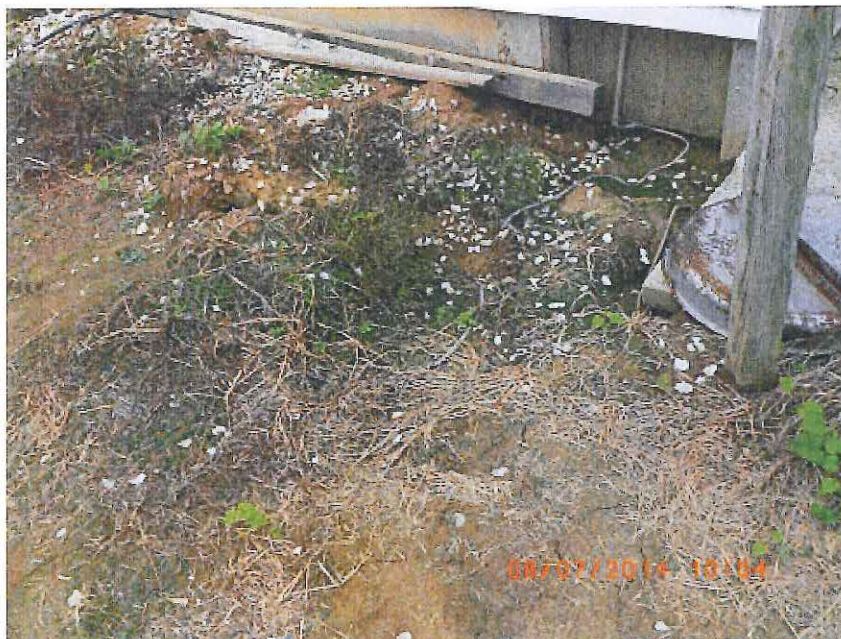
Description: Storm water can enter the barn's pit from the eroded area on the east side of Barn 7.

1. Storm water can enter the under barn pits of Barn 7 & 8 and thereby diminish the capacity of the manure ponds.
2. Feed under the bulk bin on the east side of Barn 7 needed to be removed.
3. Open pipe on the west side of Barn 8 allowed storm water to enter the manure storage pond and would diminish the capacity of the manure ponds.
4. Compost material in the Compost Building needed to be removed and land applied. The saw dust pile needed to be covered completely or stored under roof.

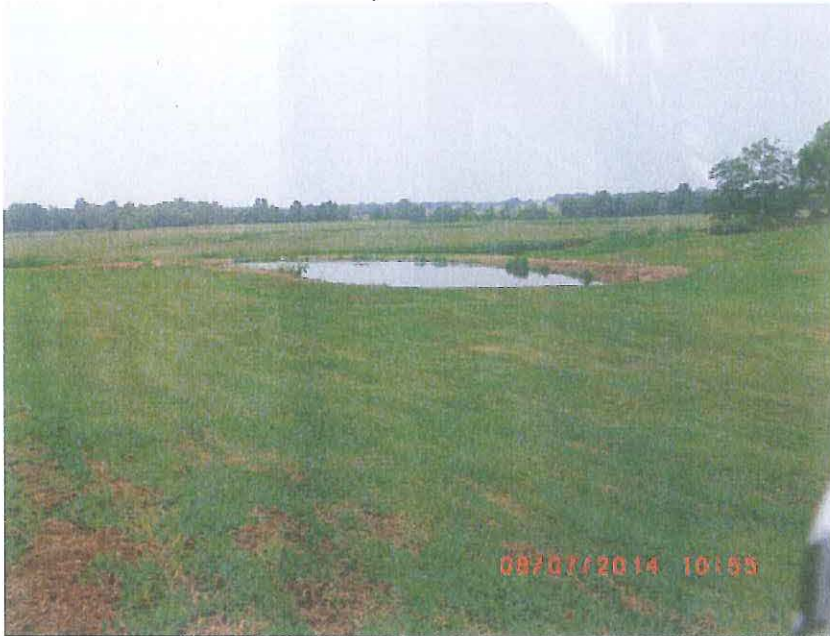
5: IMGP1225

The two cell manure ponds for these barns had approximately two feet of freeboard as indicated by the staff gauge in Pond #2. The vegetation was well maintained and there was no woody growth in the berms of either pond. During the IEPA inspection in February 2014, Pond #2 was overflowing and discharging. During this inspection, the manure pond was not discharging.

Description: Pond #2 for Barns 7 & 8 has approximately two feet of freeboard.

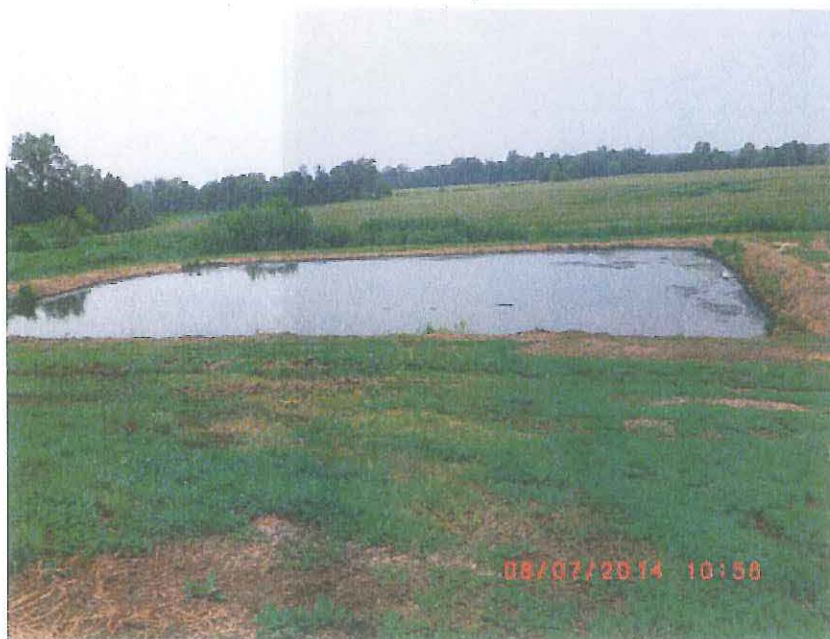
6: IMGP1226

Description: Vegetation is kept mowed around Pond #1 for Barns 7 & 8. Manure and process wastewater from Barns 7 & 8 flow via gravity to Pond #1.

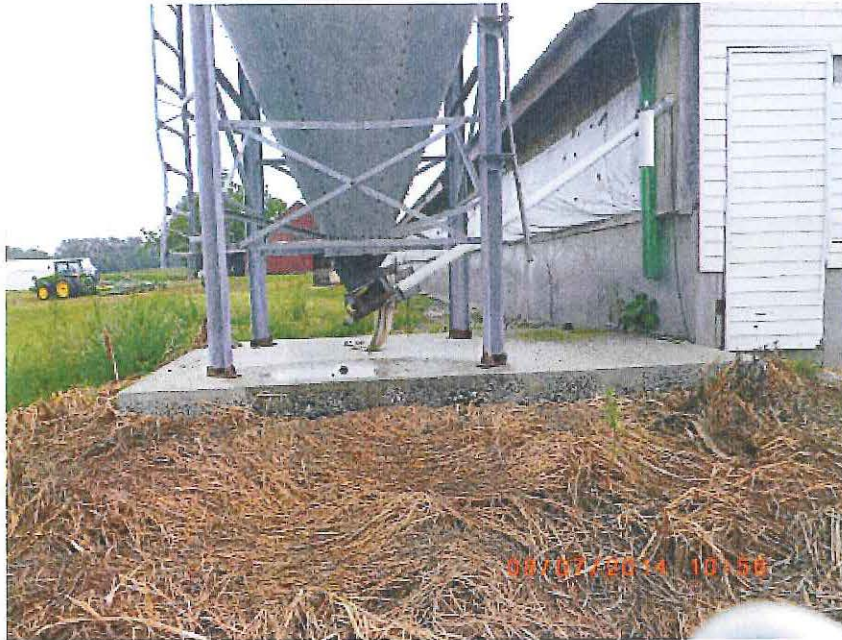
7: IMGP1227

Description: No feed spilled under the bulk bin for Barn 8.

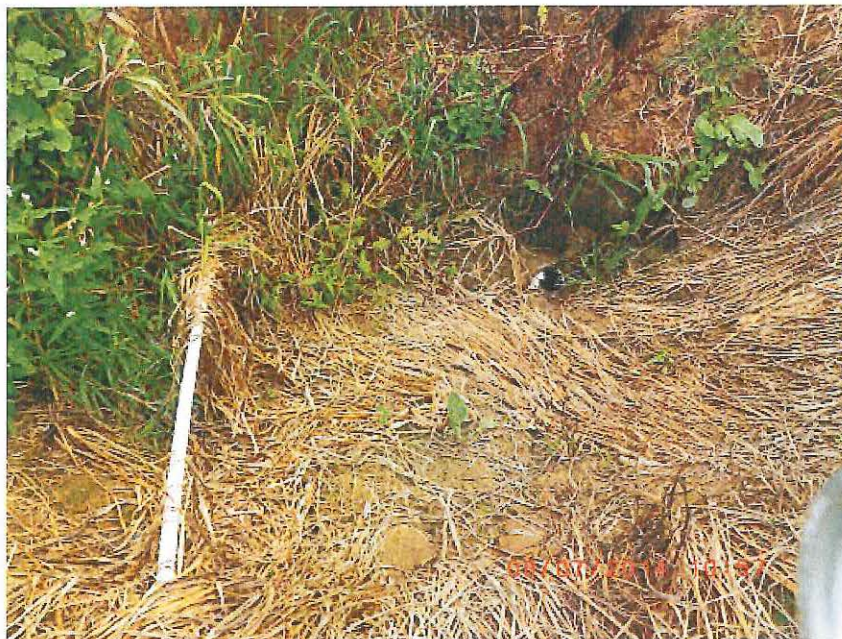
8: IMGP1228

At the west end of Barn 8, EPA observed an open pipe in a hole. The owner explained that the hole was dug and the pipe exposed in order to unclog the manure line from the barns. The open pipe also would allow additional storm water to enter the manure ponds and the owner was advised to cap the pipe.

Description: Storm water can access an open pipe west of Barn 8 and flow to Pond #1.

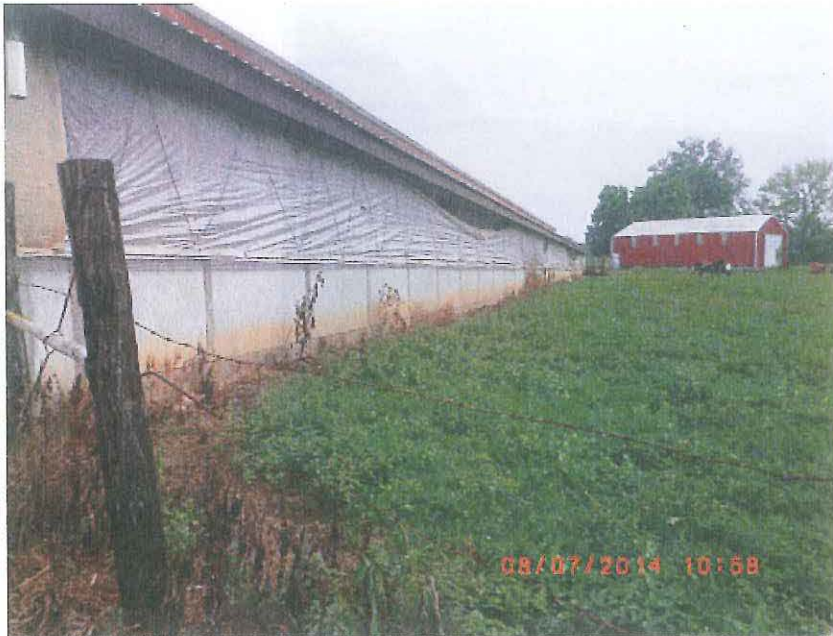
9: IMGP1229

Description: South side of Barns 7 & 8.

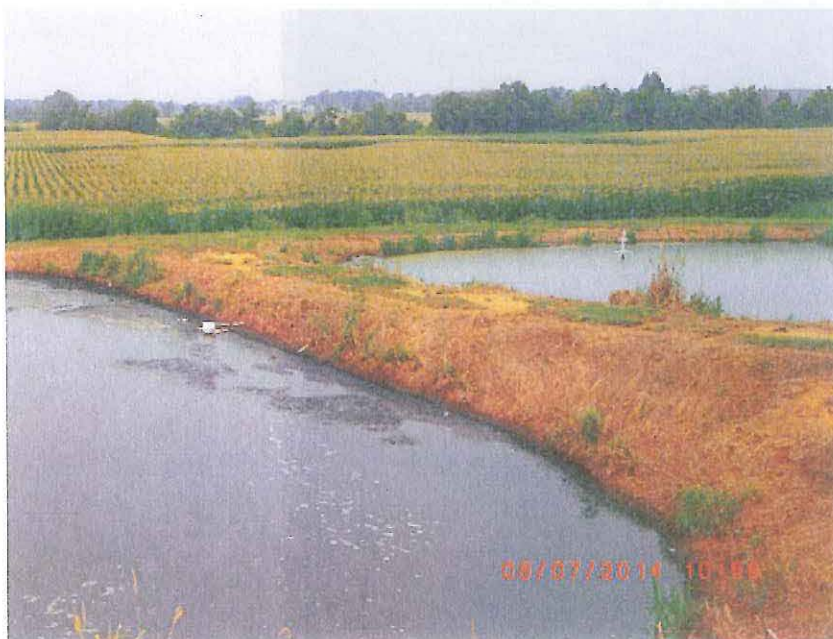
10: IMGP1230

Description: Overflow pipe from Pond #1 to Pond #2 for Barns 7 & 8 and staff gauge in Pond #2.

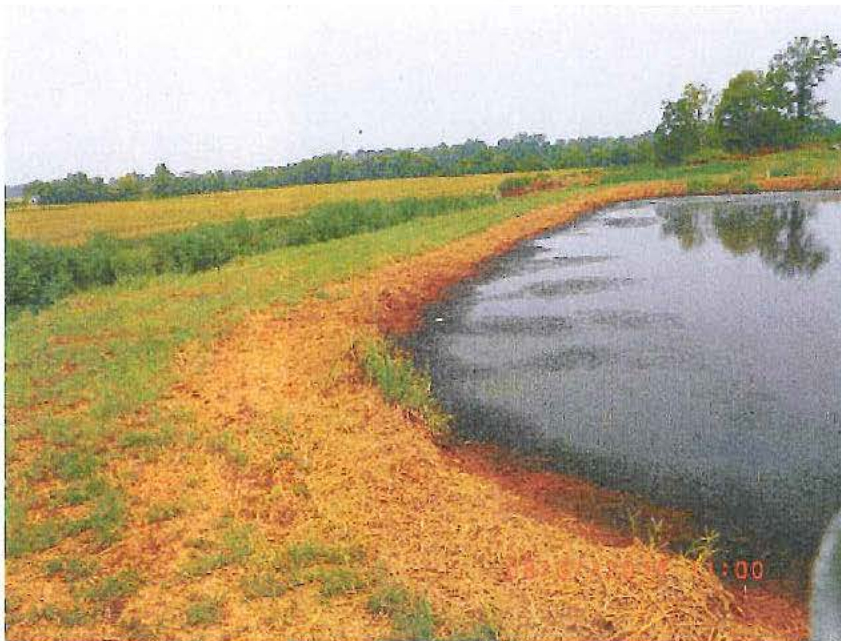
11: IMGP1231

Description: West side of Pond #1 for Barns 7 & 8.

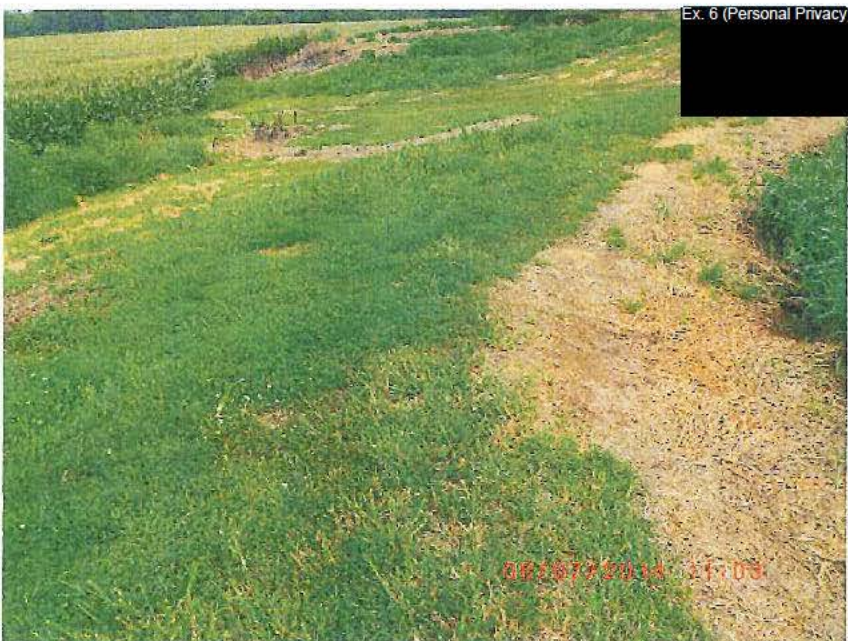
12: IMGP1232

Description: West side of Pond #2 for Barns 7 & 8. Vegetation is mowed and no woody growth. Also the location of an observed discharge by IEPA on February 20, 2014.

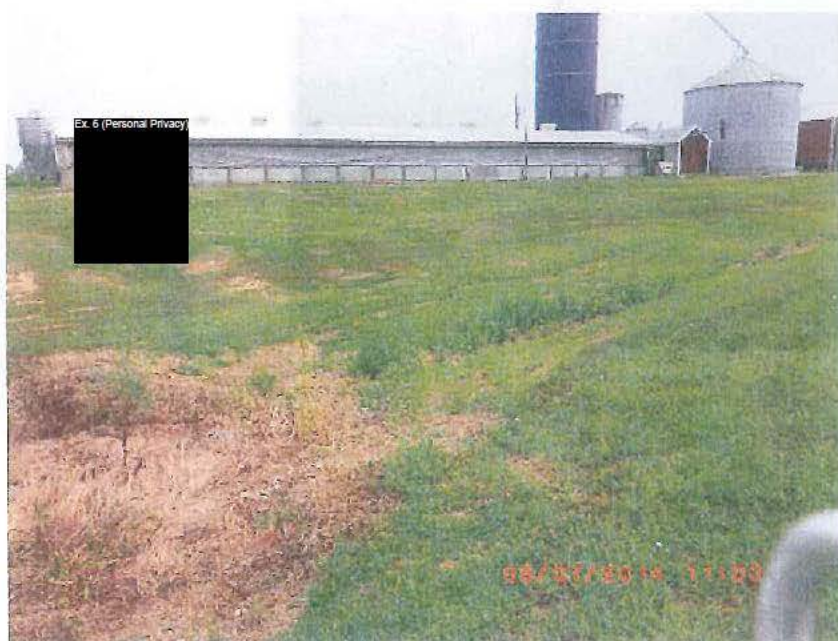
13: IMGP1233

North of Pond #2 for Barns 7 & 8, EPA observed a channel that would transport storm water to the west and to a storm water ditch. The channel had a culvert that assisted the flow from east to west. The storm water ditch to the west flowed to the south. During the IEPA inspection in February 2014, a discharge of manure and process wastewater from the pit below Barn 2 flowed into this channel and then to the storm water ditch. On the day of this inspection, there was no manure or process wastewater entering the storm water channel.

Description: Storm water channel between barns transports flow to a storm water ditch on the west side of the facility. Barn 2 is in background.

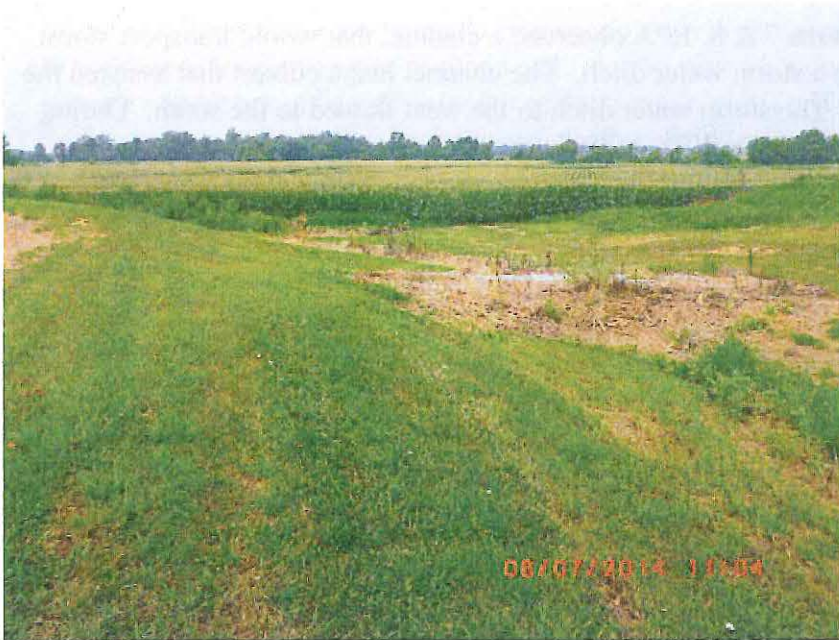
14: IMGP1234

Description: A culvert under the berm carries storm water to the west to a ditch.

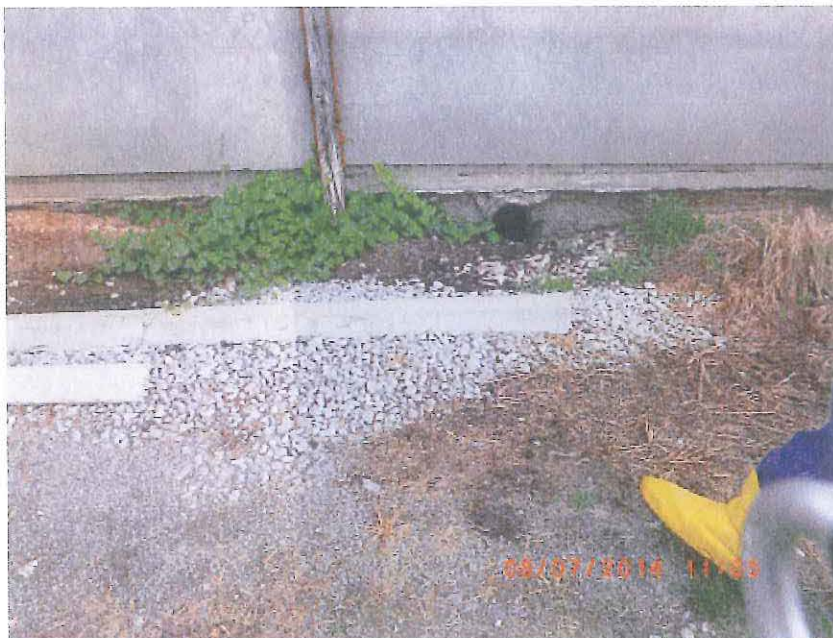
15: IMGP1235

EPA walked north to observe Barns 2, 3 and 4 and the three cell manure pond system for these barns. The clean out holes for Barn 2's deep pit was at ground level and storm water could enter the pit from the holes. During IEPA's February 2014 inspection, the pit was discharging out of the holes. During this inspection, EPA noted from inside the barn that there was four feet of freeboard in the pit.

Description: Clean out holes for Barn 2's deep pits are at ground level. Also the location of a discharge observed by IEPA on February 20, 2014.

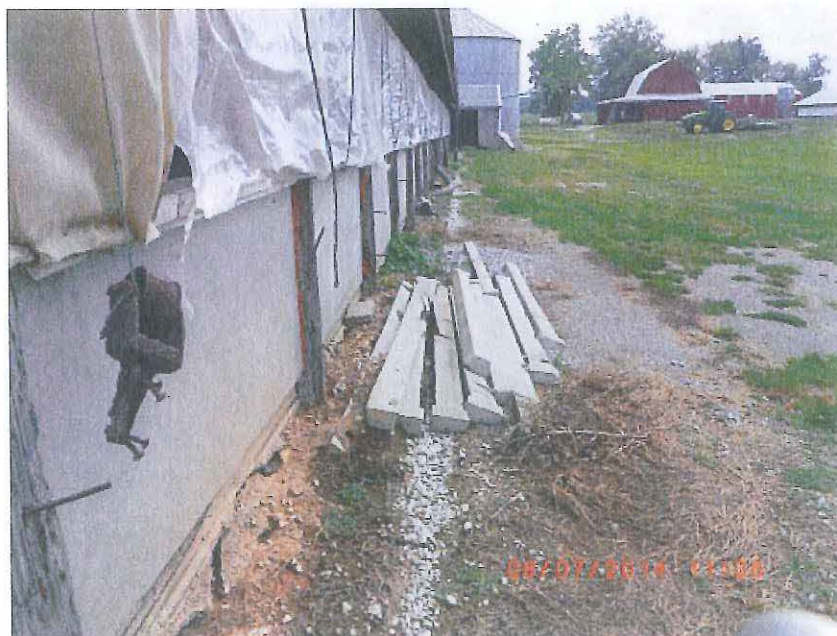
16: IMGP1236

Description: South side of Barn 2.

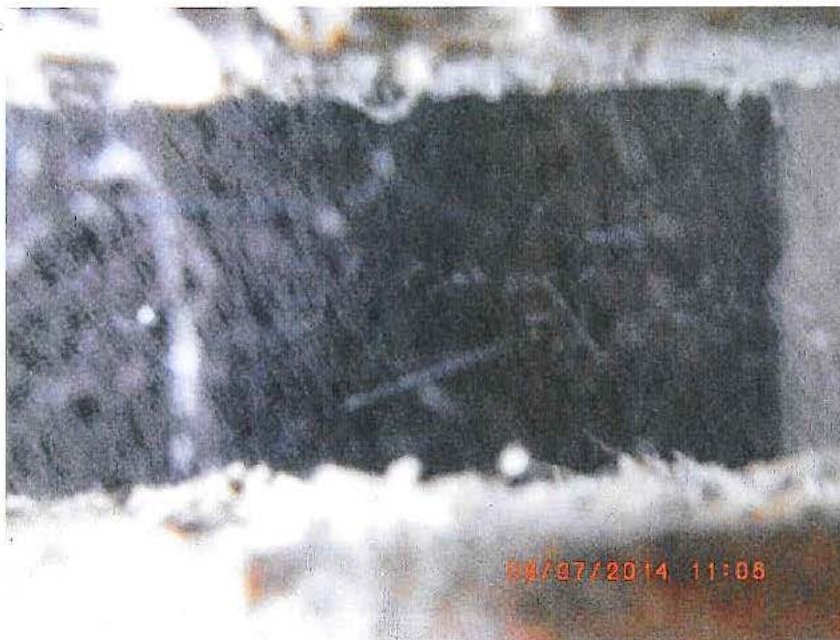
17: IMGP1237

Description: Level of manure in Barn 2's pit was approximately four feet.

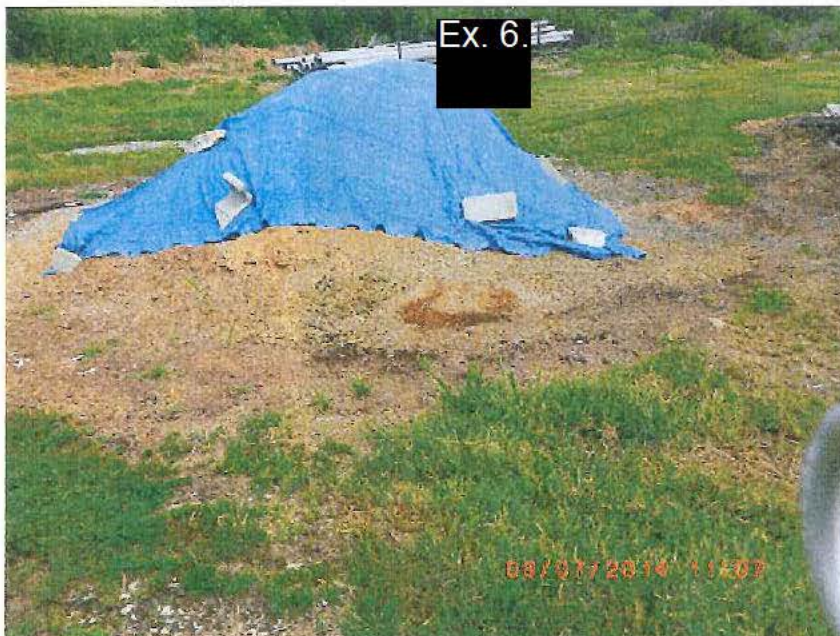
18: IMGP1238

Description: Sawdust pile is not completely covered.

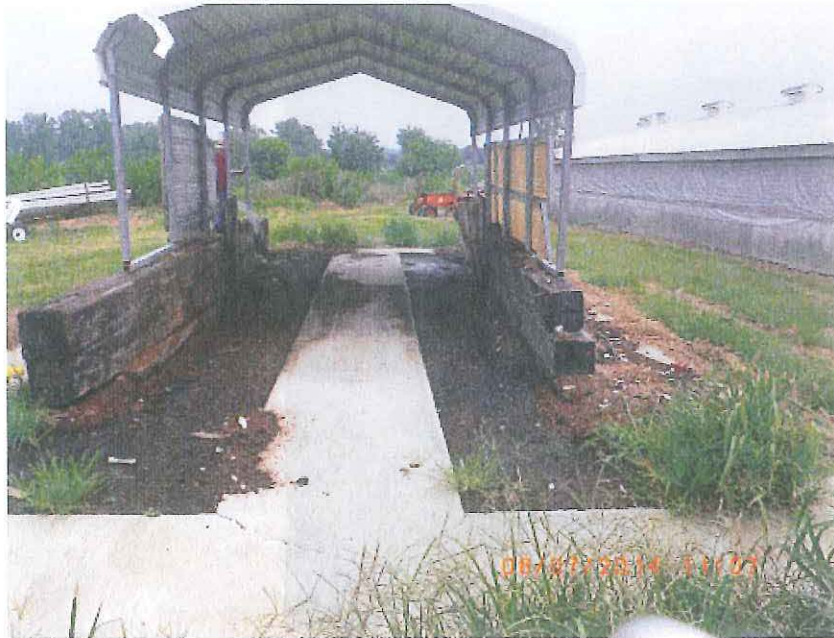
19: IMGP1239

EPA walked north along the west side of the barns and on the east side of the manure ponds. The Compost Building was located west of Barn 3. During the IEPA's February 2014 inspection, there was runoff from this area from the mortalities and sawdust pile. During this inspection, EPA observed that the mortalities had been removed and the sawdust pile had been covered although not completely. The two concrete channels on the compost pad were still filled with compost material that needed to be land applied. The roof structure did not completely cover the concrete pad and there was still the potential for precipitation to come in contact with compost material and run off. EPA noted bones from mortalities laying around in the yard by the Compost Building.

Description: Compost Building is not completely covered. Mortalities have been removed, but concrete channels on either side still have compost that needs to be land applied.

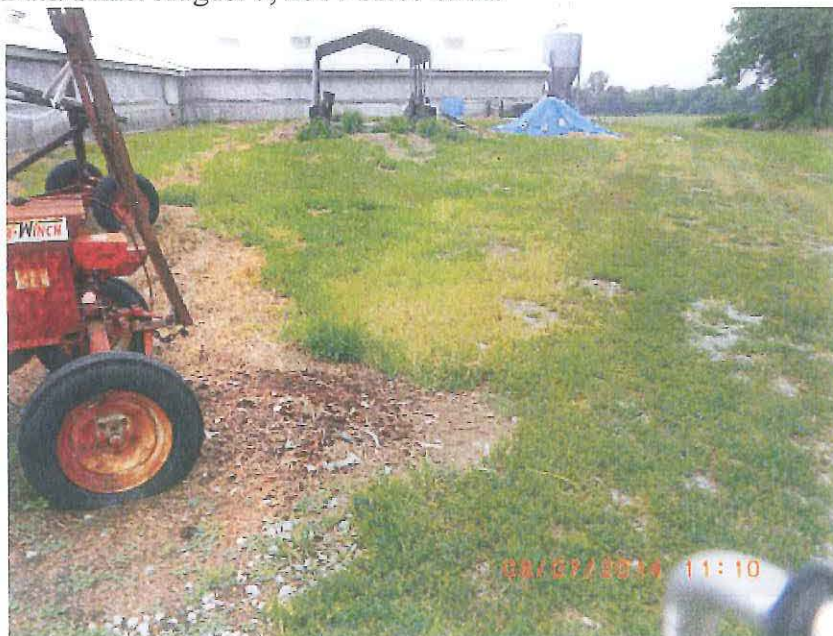
20: IMGP1240

Description: Compost Building is not completely cleaned out.

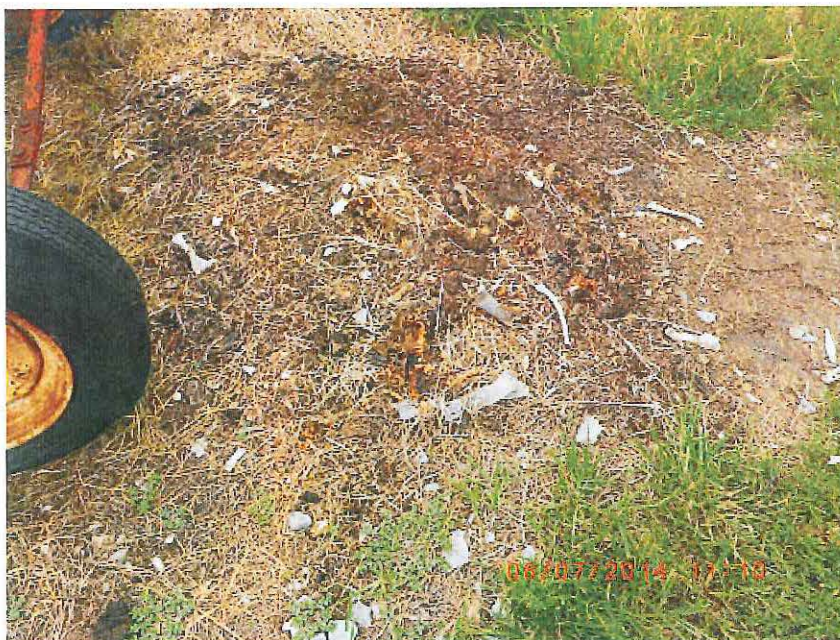
21: IMGP1241

Description: Some bones from scavenged mortalities are laying around in the yard.

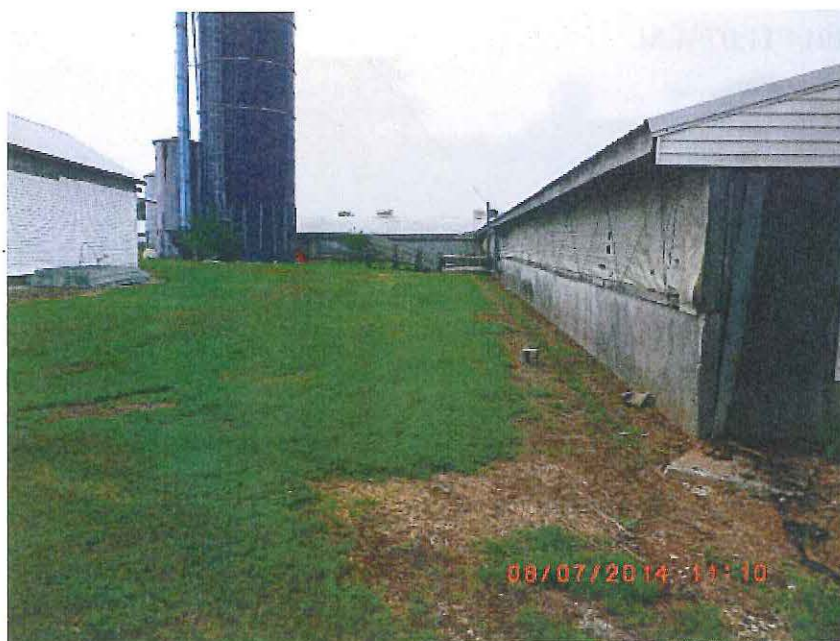
22: IMGP1242

Description: East side of Barn 3 and Barn 2 in background.

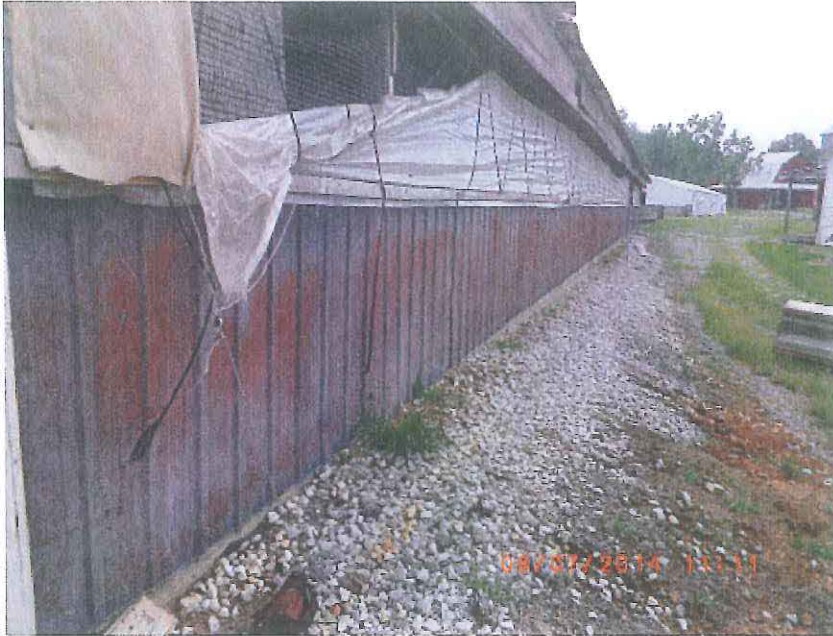
23: IMGP1243

Description: Barn 4 utilizes a flush gutter system under slats.

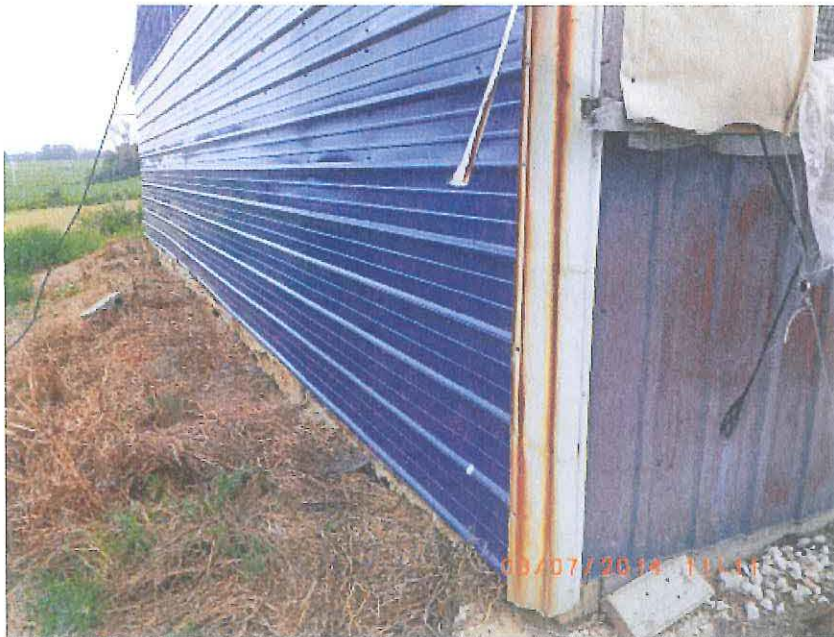
24: IMGP1244

Description: Barn 4

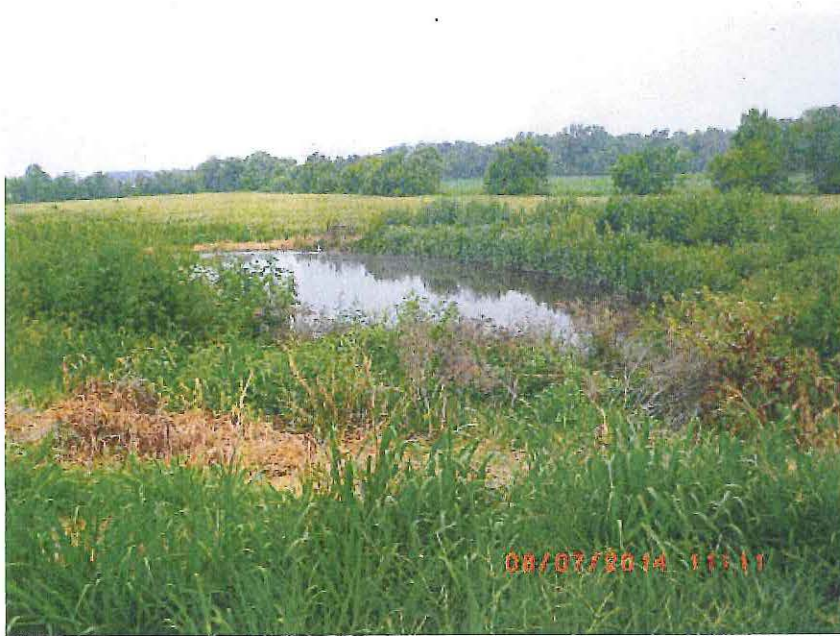
25: IMGP1245

Then EPA walked along the north and west berms of the three manure ponds. The vegetation was very high and there was woody growth growing out of the berms. The berms were very steep on the north and west sides. During the IEPA's February 2014 inspection, Pond #1 was overflowing at the northern side. The owner has since built up that side of the berm. There was approximately 1.5 feet of freeboard in Pond #1 as indicated by a staff gauge in that pond.

Description: Pond #1 for Barns 2, 3, and 4 has a lot of tall vegetation and woody growth on the berms.

5. Woody growth needed to be removed from the three cell manure storage ponds.
6. Tall vegetation needed to be mowed on the three cell manure storage ponds.
7. Needed to remove more liquid from three cell manure ponds system to get down to the two feet of freeboard as required by the VN.

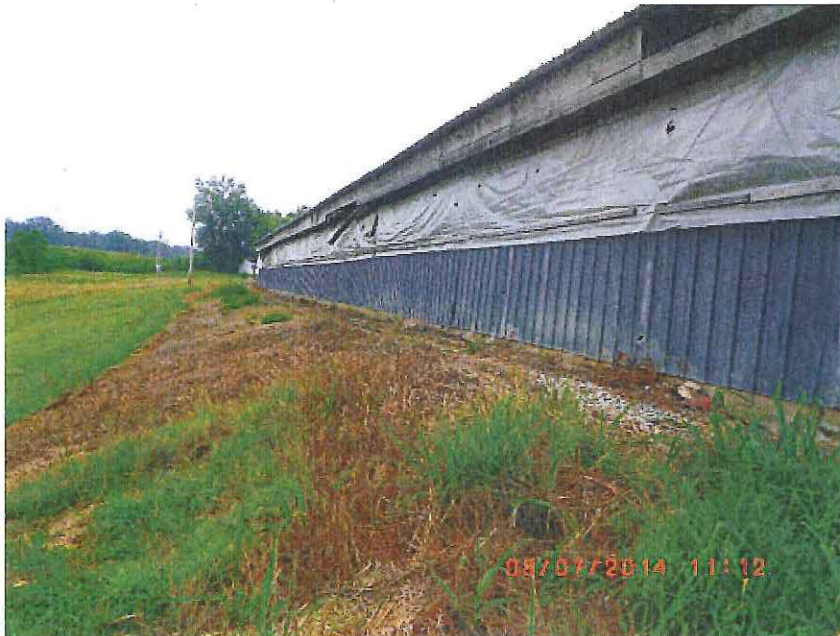
26: IMGP1246

Description: North side of Barn 4.

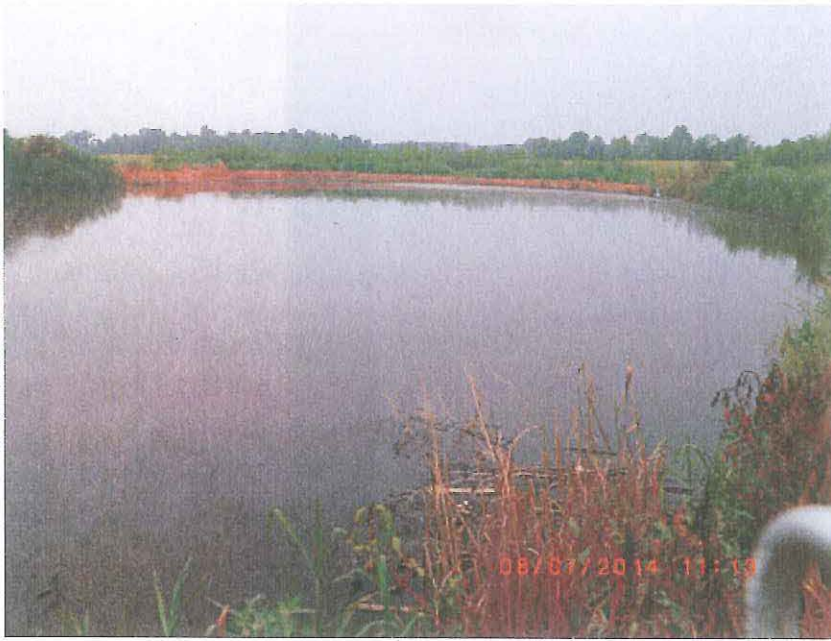
27: IMGP1247

Description: Pond #1 for Barns 2, 3, and 4 has about 1.5 feet of freeboard.

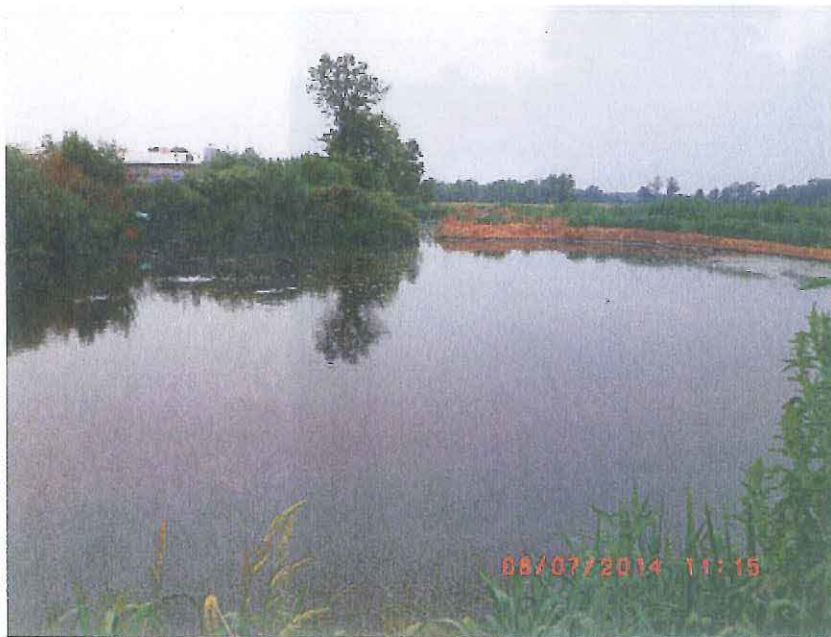
28: IMGP1248

Description: Pond #1 overflows into Pond #2 through channel in berm wall.

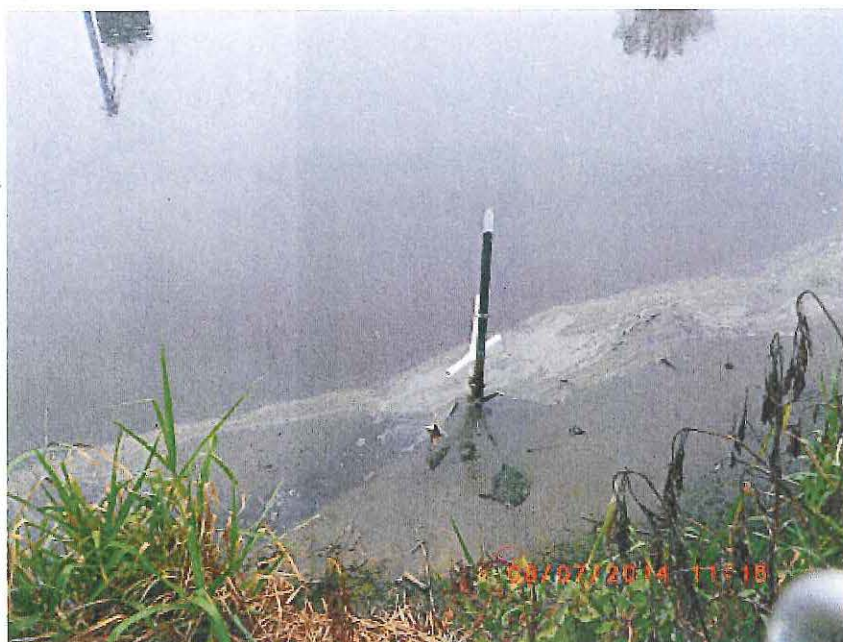
29: IMGP1249

Description: Depth marker for Pond #1 indicates approximately 1.5 feet of freeboard.

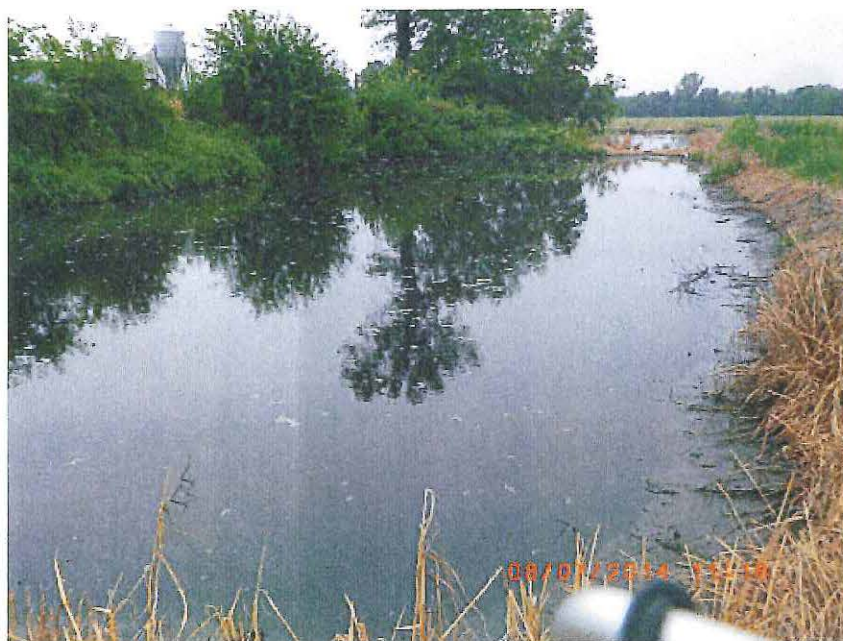
30: IMGP1250

Description: Pond #2 overflows into Pond #3 to the south.

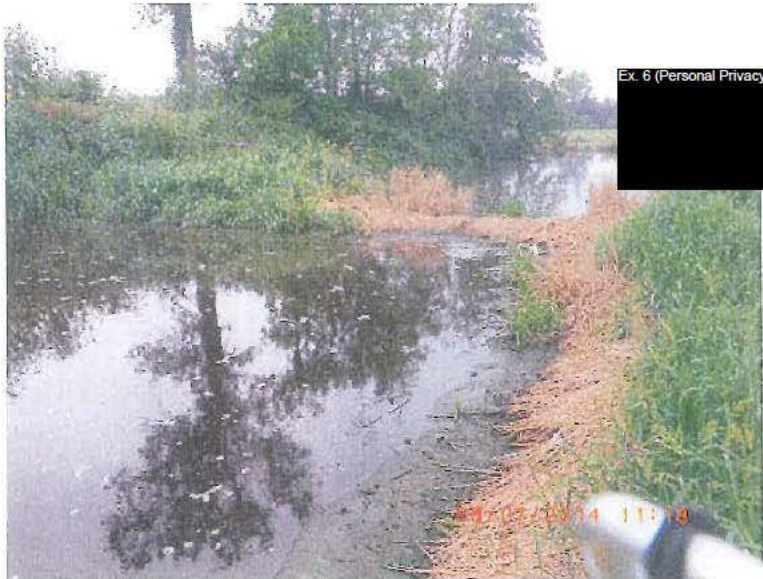
31: IMGP1251

Description: Ponds #2 and #3 need to have the vegetation mowed on the berms and need to have the woody growth removed.

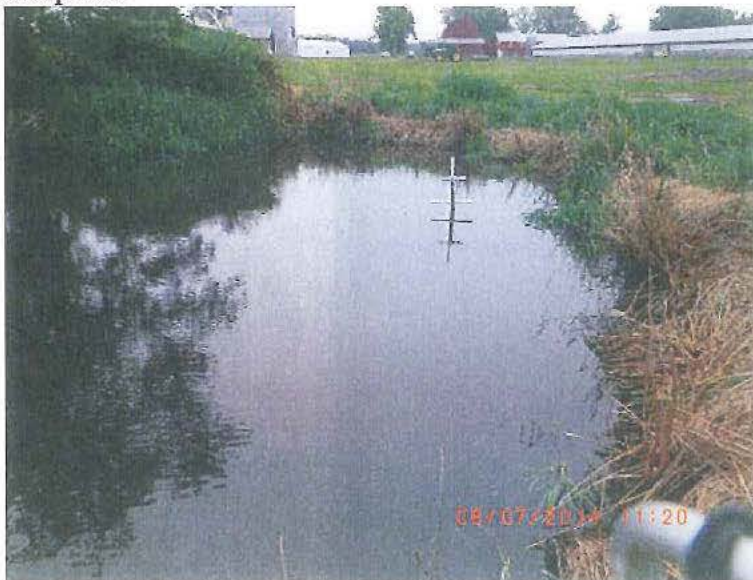
32: IMGP1252

A staff gauge in Pond #3 indicated that there was approximately 2.5 feet of freeboard in that pond.

Description: Staff gauge in Pond #3 indicates that there is approximately 2.5 feet of freeboard.

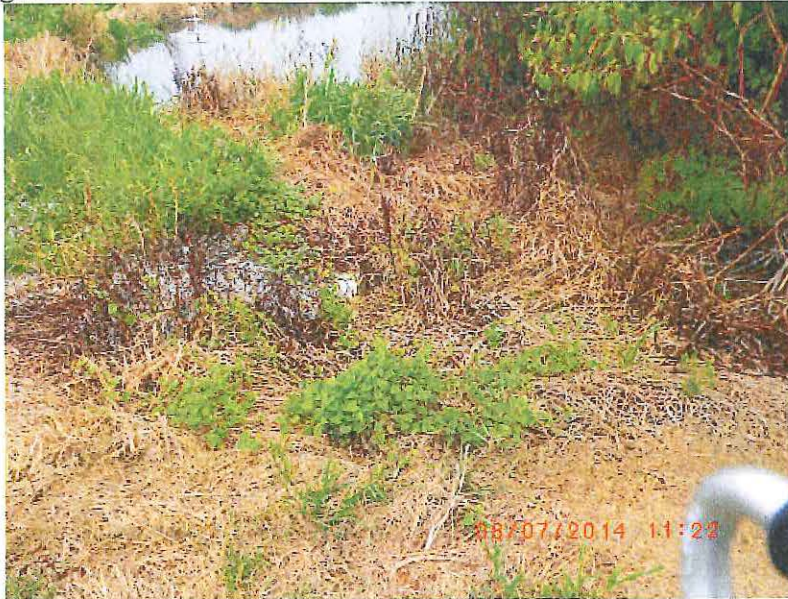
33: IMGP1253

At the southeast corner of Pond #3 stormwater from the north is diverted away from the pond and to the storm water channel in the yard to the south. A culvert assists the flow to go to the south.

Description: Culvert pipe for storm water that collects on the southeast side of Pond #3 transports the flow to the storm water channel to the south.

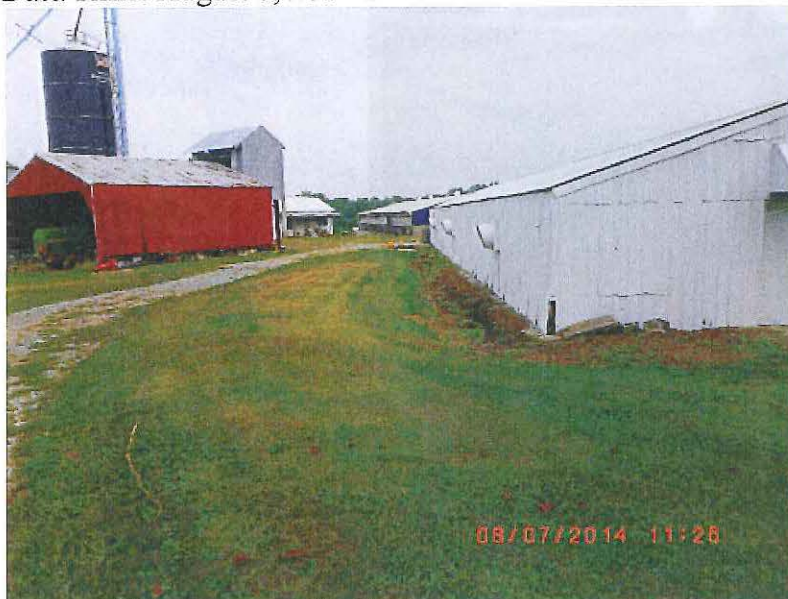
34: IMGP1254

Description: Utility barns and feed storage.
